DEPARTMENT OF TRANSPORTATION

Contract #: 04-0120F4Cty: SF/ALA Rte: 80 PM: 13.2/13.9File #: 1.28**WELDING INSPECTION REPORT****Resident Engineer:**Siegenthaler, Peter**Address:** 333 Burma Road**City:** Oakland, CA 94607**Report No:** WIR-023093**Date Inspected:** 25-Apr-2011**Project Name:** SAS Superstructure**OSM Arrival Time:** 700**Prime Contractor:** American Bridge/Fluor Enterprises, a JV**OSM Departure Time:** 1530**Contractor:** American Bridge/Fluor Enterprises, a JV**Location:** Job Site**CWI Name:** Fred Von Hoff**CWI Present:** Yes No**Inspected CWI report:** Yes No N/A**Rod Oven in Use:** Yes No N/A**Electrode to specification:** Yes No N/A**Weld Procedures Followed:** Yes No N/A**Qualified Welders:** Yes No N/A**Verified Joint Fit-up:** Yes No N/A**Approved Drawings:** Yes No N/A**Approved WPS:** Yes No N/A**Delayed / Cancelled:** Yes No N/A**Bridge No:** 34-0006**Component:** Orthotropic Box Girder**Summary of Items Observed:**

WELDING INSPECTION REPORT

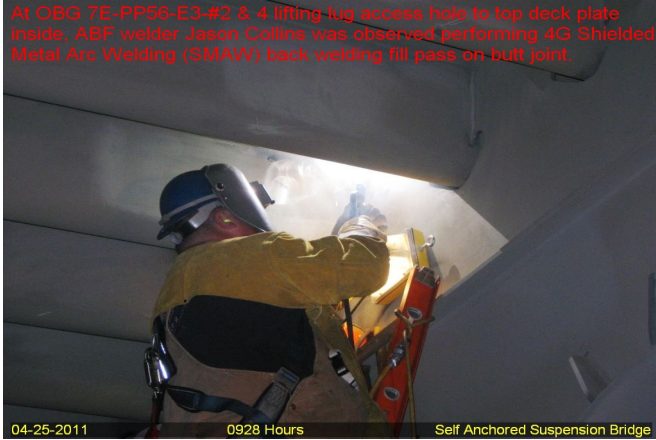
04-25-2011 0928 Hours Self Anchored Suspension Bridge

At OBG 7E-PP56-E3-#2 & 4 lifting lug access hole to top deck plate inside – ABF welder Jason Collins was observed 4G SMAW back welding fill pass to cover pass on the infill plate to top deck plate butt joints. The welder was noted using 1/8” diameter E7018H4R electrode implementing Caltrans approved Welding Procedure Specification (WPS) ABF-WPS-D15-1110A. Prior welding, ABF QC Fred Von Hoff was observed performing Magnetic Particle Testing (MT) on the back gouging and grinding of the butt joints. During welding, ABF QC Fred Von Hoff was noted monitoring the welder’s welding parameters. At the end of the shift, cover pass welding on the bottom side location of the two butt joints was completed and the welder has moved to #1 & 3 access holes of the same OBG and performed back gouging using carbon air arc.

At OBG 7E-PP56-E3-#2 & 4 lifting lug access hole to top deck plate inside, ABF welder Jason Collins was observed performing 4G Shielded Metal Arc Welding (SMAW) back welding fill pass on butt joint.

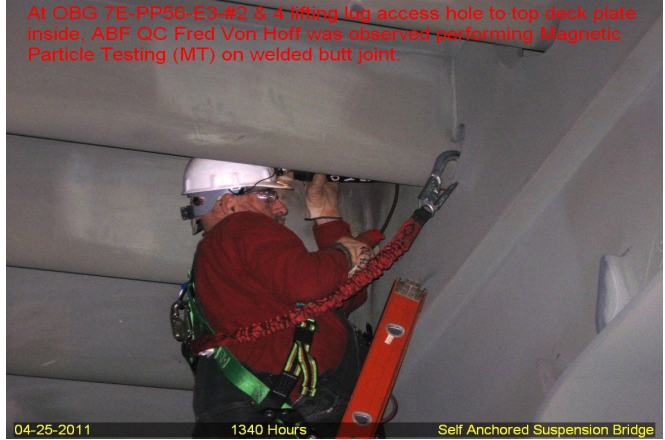
04-25-2011 1340 Hours Self Anchored Suspension Bridge

At OBG 7E-PP56-E3-#2 & 4 lifting lug access hole to top deck plate inside, ABF QC Fred Von Hoff was observed performing Magnetic Particle Testing (MT) on welded butt joint.

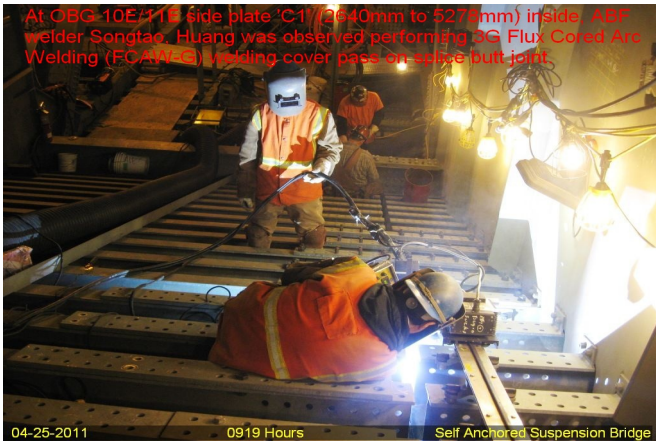
04-25-2011 0919 Hours Self Anchored Suspension Bridge

At OBG 10E/11E side plate 'C1' (2640mm to 5278mm) inside, QA randomly observed ABF/JV qualified welder Sungtao, Huang ID # 3794 continuing to perform CJP groove (splice) welding fill pass to cover pass on the splice butt joint. The welder was observed perform automatic welding in the 3G (vertical) position utilizing a dual shield Flux Cored Arc Welding (FCAW-G) with E71T-1M, 1/16" diameter wire electrode and implementing Caltrans approved Welding Procedure Specification (WPS) ABF-WPS-D15-3042B-1. The joint being welded has a single V-groove butt joint with backing bar. The splice joint was preheated and maintained to greater than 150 degrees Fahrenheit using Miller Proheat 35 Induction Heating System heater blankets located at the opposite side of the plate prior/during welding. During welding, ABF Quality Control (QC) Fred Von Hoff was noted monitoring the welding parameters of the welder. At the end of the shift, cover pass welding was completed and the welder has moved to 'C2 (2640mm to 4577mm) inside of the same OBG plate.

At OBG 10E/11E side plate 'C1' (2940mm to 5275mm) inside, ABF welder Songtao Huang was observed performing 3G Flux Cored Arc Welding (FCAW-G) welding cover pass on splice butt joint.

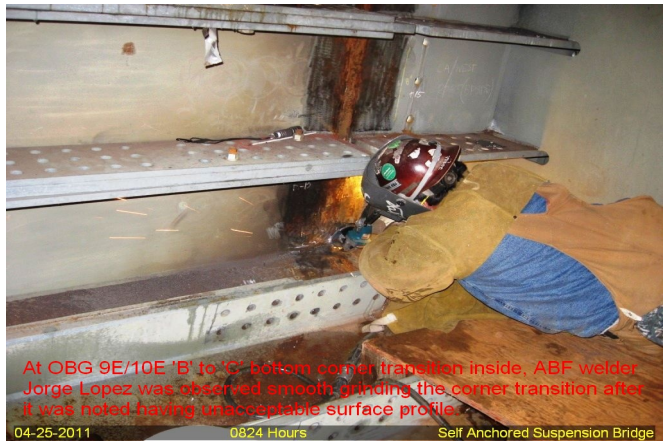
04-25-2011 0824 Hours Self Anchored Suspension Bridge

At OBG 9E/10E ‘A’ to ‘B’ (top corner transition) and ‘B’ to ‘C’ (bottom corner transition) inside, ABF welder Jorge Lopez was noted fixing the two transition corners by grinding and touch up welding where undercut was noted. The welder was noted using 1/8” diameter E7018H4R electrode. During welding, ABF QC Fred Von Hoff was noted monitoring the welder’s welding parameters. At the end of the shift, touch up welding and smooth grinding on both transitions was completed. The welder has moved to the other side of the OBG 9E/10E ‘A’ to ‘F’ (top corner transition) and ‘F’ to ‘E’ (bottom corner transition) inside where the welder carried out the same as he previously did. All four corner transitions were all completed at the end of the shift and were visually checked and verified by QC and QA respectively.

At OBG 9E/10E 'B' to 'C' bottom corner transition inside, ABF welder Jorge Lopez was observed smooth grinding the corner transition after it was noted having unacceptable surface profile.
